Home Report

Scottish Single Survey

Property address	31 The Hennings Sauchie Alloa FK10 3ES
Customer	Mr & Mrs Gerry
Customer address	31 The Hennings Sauchie Alloa FK10 3ES
Prepared by	Shepherd Chartered Surveyors
Date of inspection	02/12/2024

**Energy
Performance
Certificate**

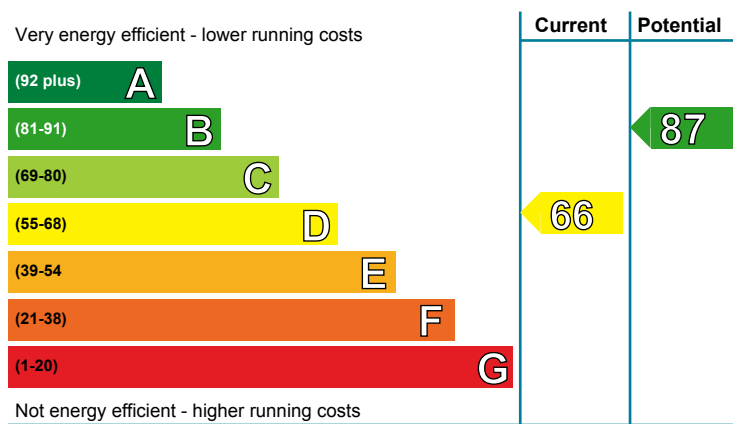
Energy Efficiency Rating

This graph shows the current efficiency of your home, taking into account both energy efficiency and fuel costs. The higher this rating, the lower your fuel bills are likely to be.

Your current rating is **band D (66)**. The average rating for EPCs in Scotland is **band D (61)**.

The potential rating shows the effect of undertaking all of the improvement measures listed within your recommendations report.

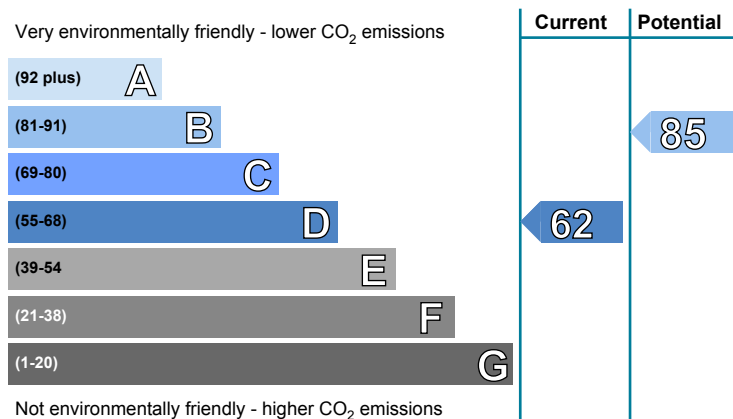
Environmental Impact (CO₂) Rating

This graph shows the effect of your home on the environment in terms of carbon dioxide (CO₂) emissions. The higher the rating, the less impact it has on the environment.
